ARKANSAS STATE HOSPITAL (ASH) – Hospital Administration,
Canteen, Nursing Administration and Admissions Buildings

Building Location: 4313 W Markham Street Little Rock, Arkansas

Date of Site Visit: 9/07/06

Field Notes, Background & General Observations

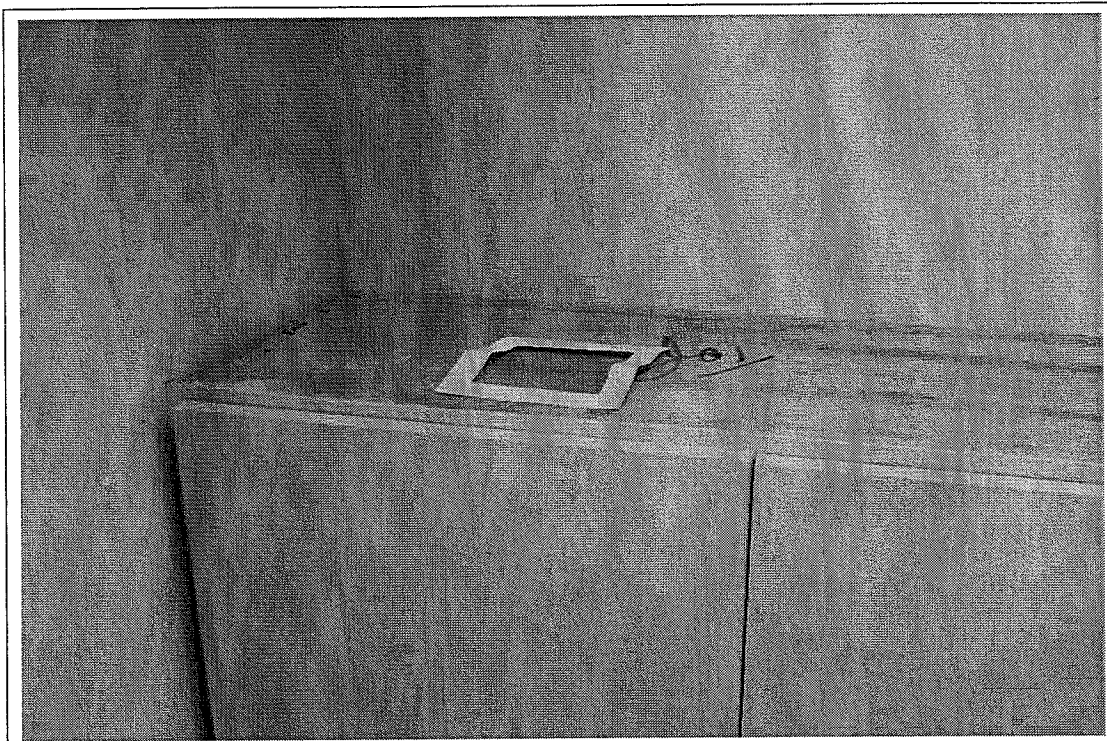
Photo 28. 4th floor, Room 414 (break room) - Location of dust sample #2 (top of wall mounted cabinets)

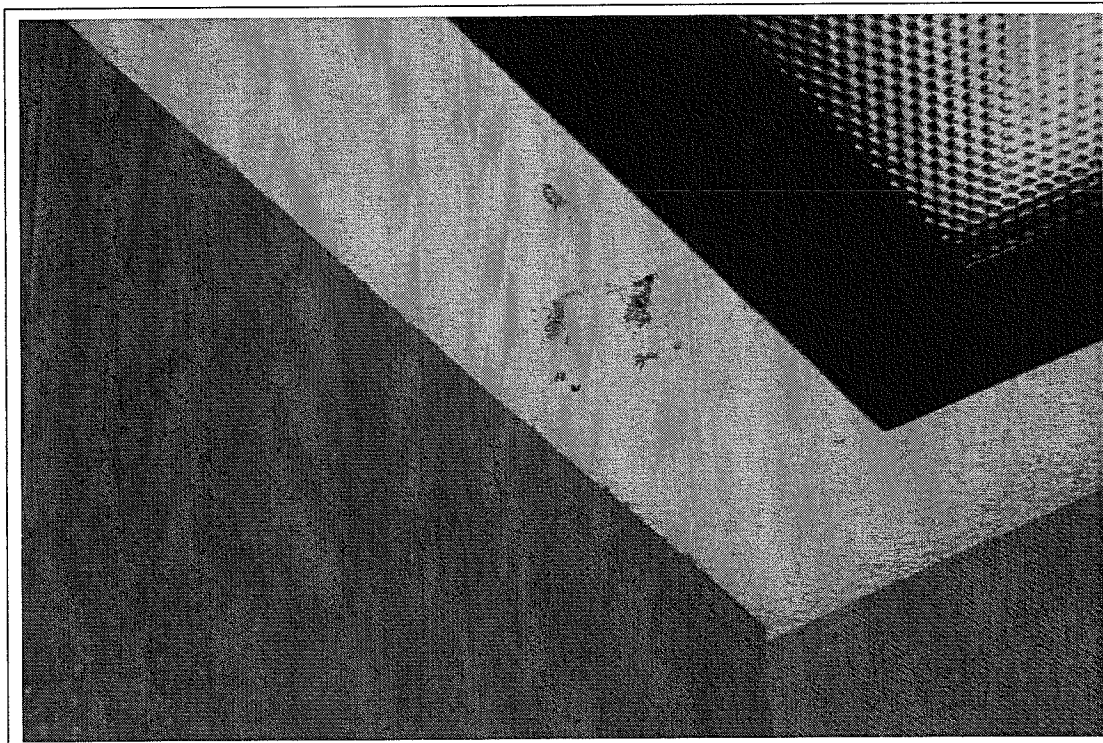
Photo 29. 3rd floor, outside room 311 - Impact damage at recessed light fixture

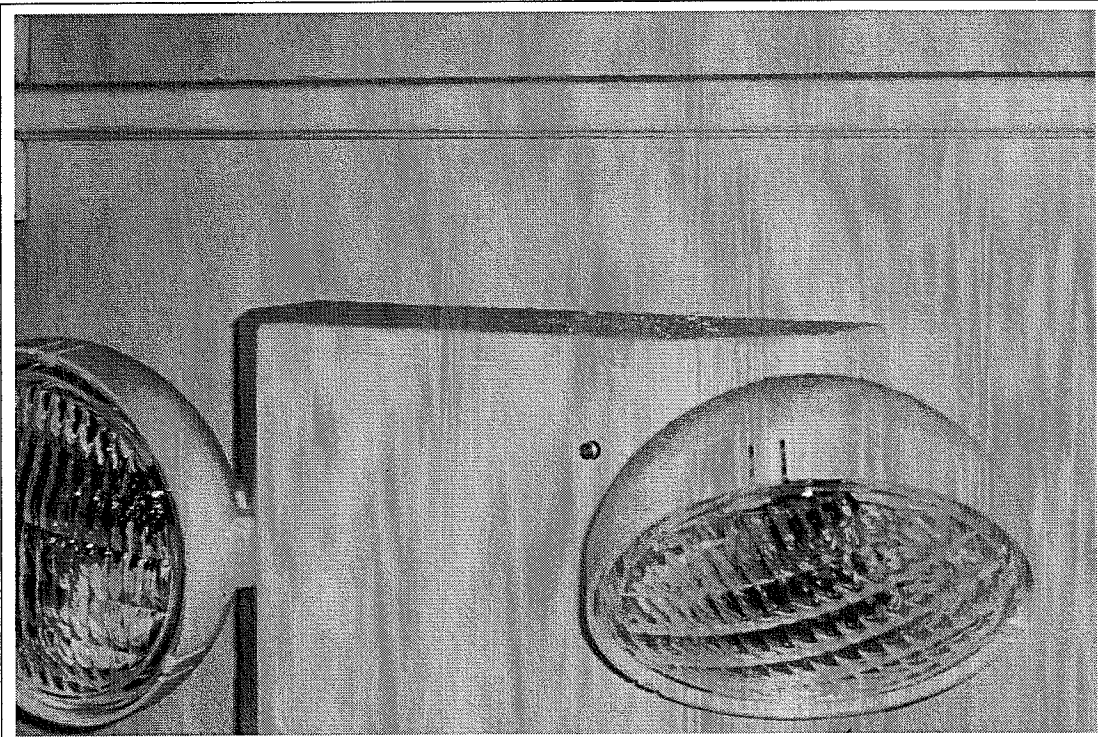
Photo 30. 3rd floor, west hall adjacent to lobby - Location of dust sample #3 -Top of emergency light

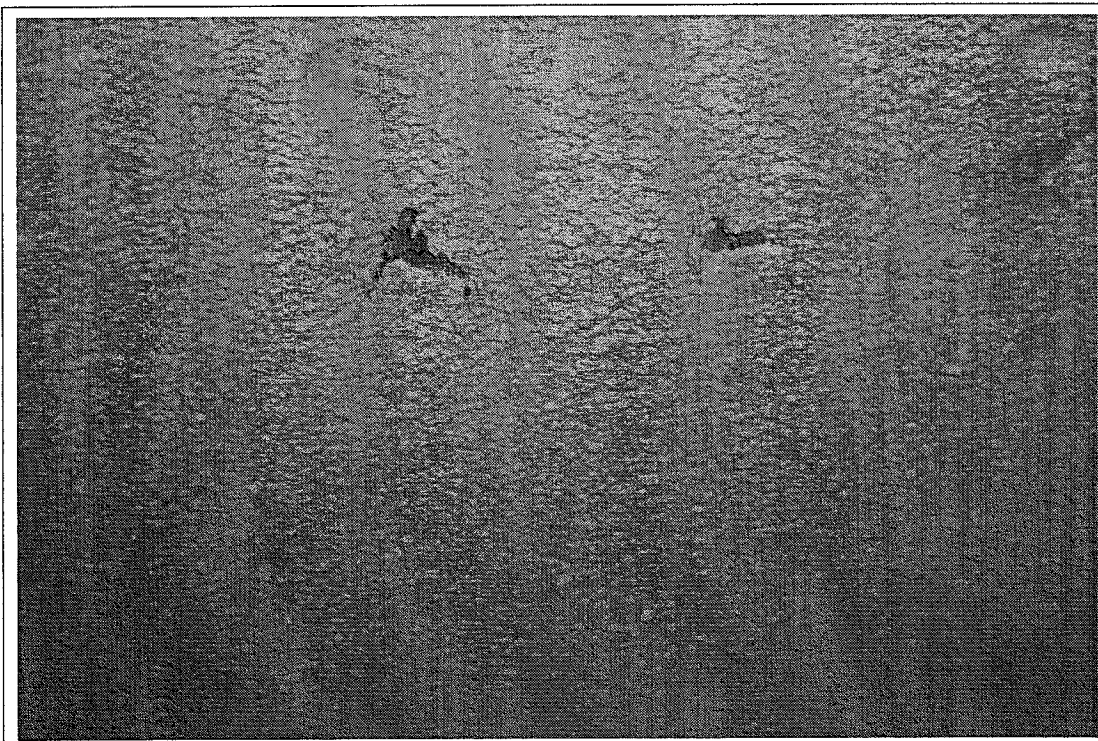
Photo 31. B Floor - east hallway - Close-up of damaged acoustical plaster in hallway

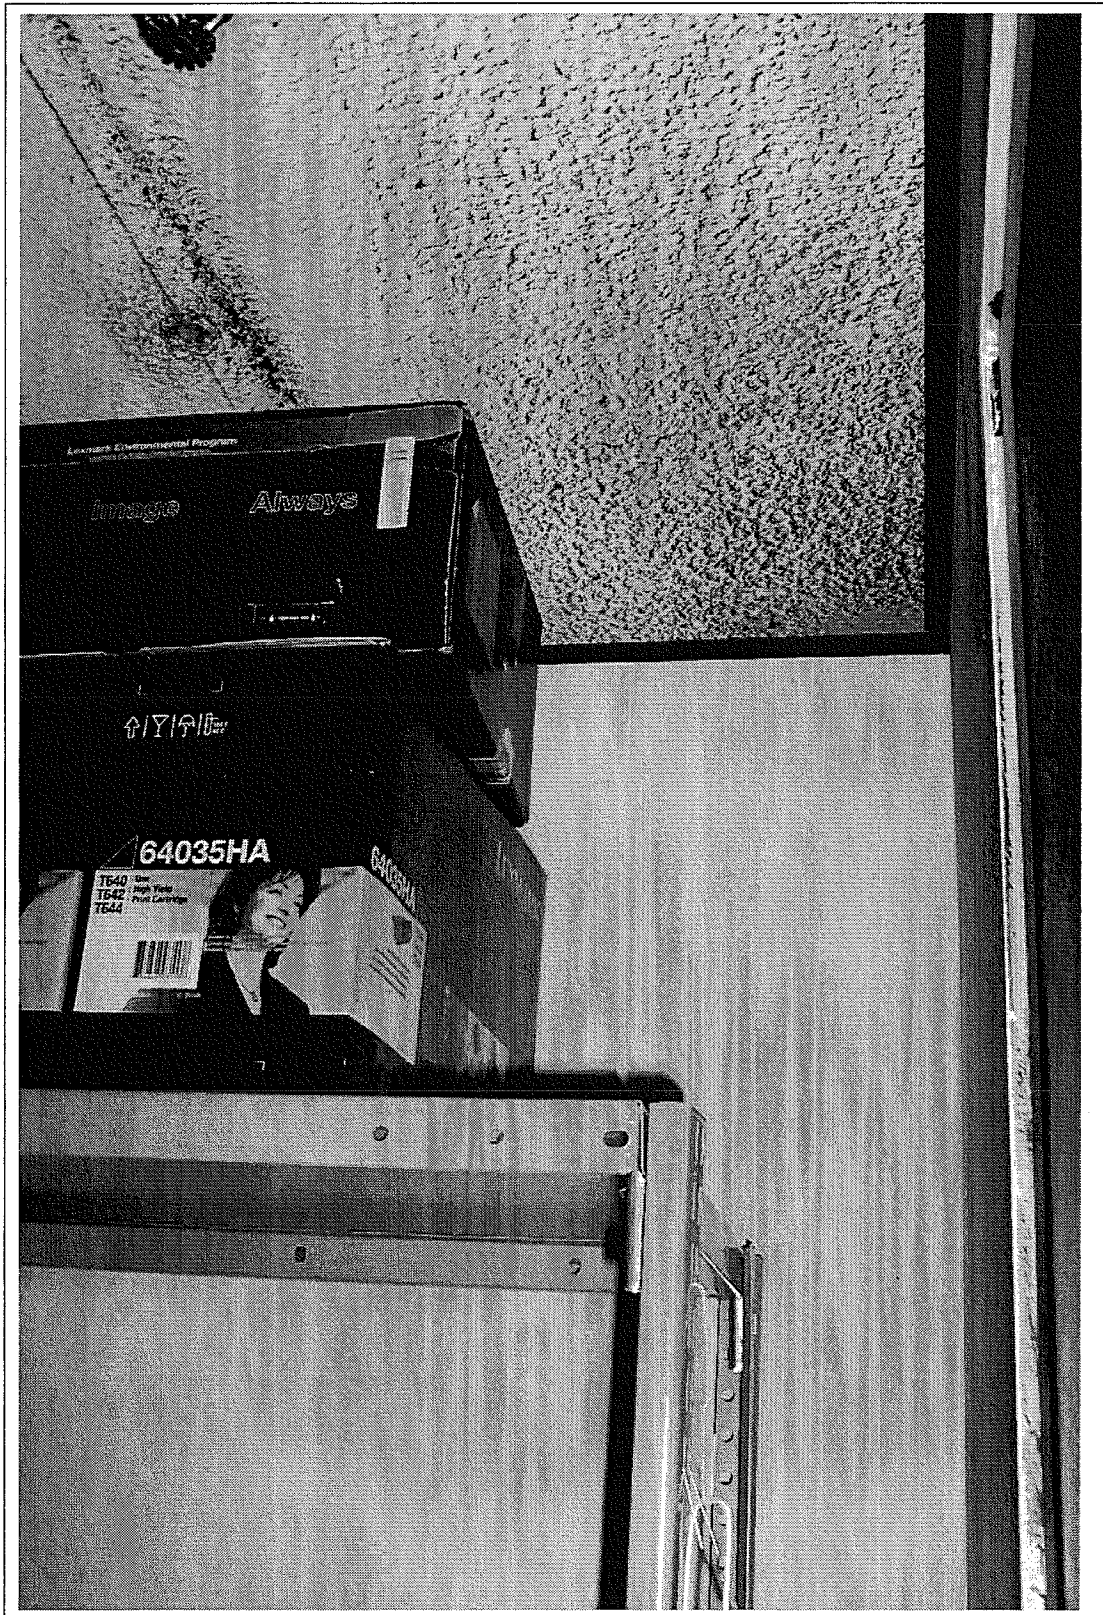
Photo 32. B Floor - Purchasing B7/B5 - View of acoustical plaster in storage room
(location of dust sample #4 – top of shelf)
